POPPLETON HISTORIC STUDY

B-2556

Block Lot Address
200 38-49 1077-1099 W. Fayette Street

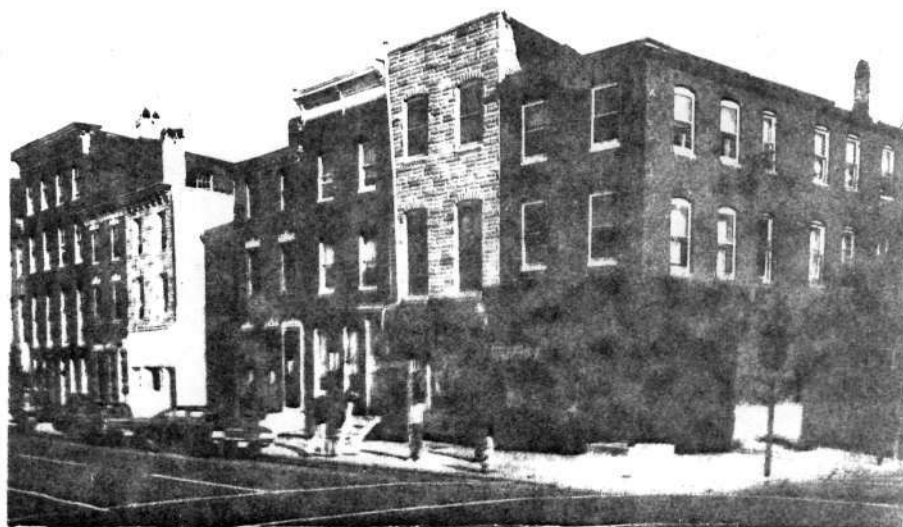
1087 1089

The whole terrace dates from the late 1860's to the early 1870's. Number 1079 has filigree windows and metalwork. Number 1081 is a store front, in part added later; its upper windows and cornices are of fine proportion and detail. Numbers 1083-1085 are a pair of four-story buildings. Number 1087 has an unusual cornice. Number 1093 has cast iron lintels, gable roof, and is of unusual design; 1087 has cast iron lintels also as did probably 1089 before its demise. Number 1095 has metal work; numbers 1097-1099 have store fronts, both original with some amendation. Number 1089 has been formstoned and made into two apartments. Number 1097 has also been formstoned with a badly modified first floor.

Number 1093 is vacant and 1091 has been torn down, along with 1069-1075 whose land is now parking asphalt for the church. Though gapped and deformed, this group should remain and be rehabilitated.
